IMPROVING A SLATERS P.O. WAGON

CHRIS CROFTS GOES 7mm FOR
'INKERMAN STREET'

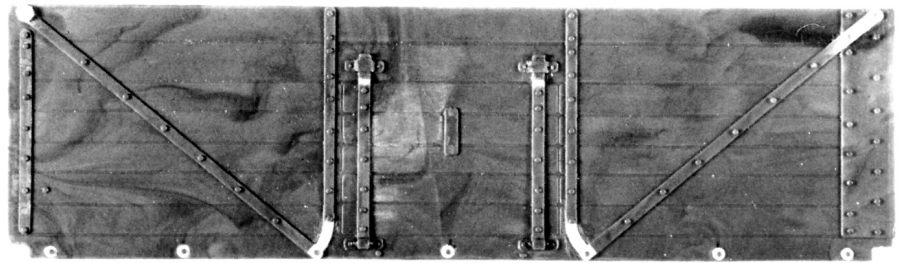
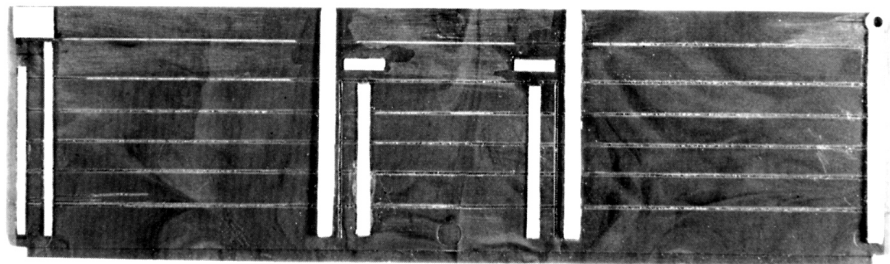
The wagon sides as modified, inside and out.

I carefully cut off the nuts on the side rail and replaced them with washers underneath. The washers were made by punching 0.005in Plastikard (yes, I still have some!) into lead sheet with the broken-off shank of a suitable drill. There was no room for washers behind the nuts under the door hinge knuckles, indicating that the said knuckles must be a little too low. I checked this with a 4mm side that I have

Washer plates and corner plates were now added from 0.010in Plastikard. Knees were of thicker stuff – they are 2in thick at the bottom – and were tapered by filing. Bolt heads were

added by cutting them out of rivet-embossed Plastikard and sticking them on individually. After the photograph was taken, the boltheads for the diagonal braces were added as well. The whole of the inside was then painted a colour to match new wood – white with a little buff added.

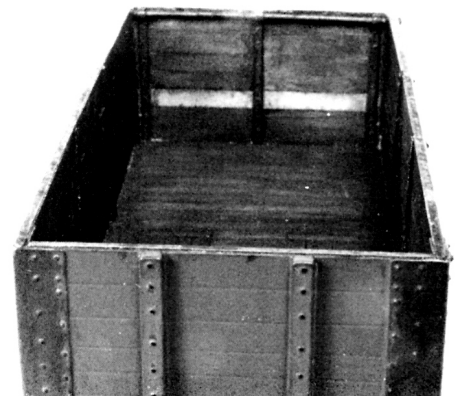
The slight outward bowing of the sides is just apparent here.

Plywood spacers were cut a little more than the inside width of the wagon and wedged in the region of the side knees, causing the sides to bow out slightly. The body was then left for at least a week for the solvent to dry, with the spacers still in place. I don't know whether this

is really necessary with O gauge wagons but I wasn't taking any chances of having the sides bowed in. Now that the wagon is finished eight months later, the sides are still slightly bowed out, just like the real ones used to. It isn't obvious at a casual glance, but a steel rule placed along the top proves the point.

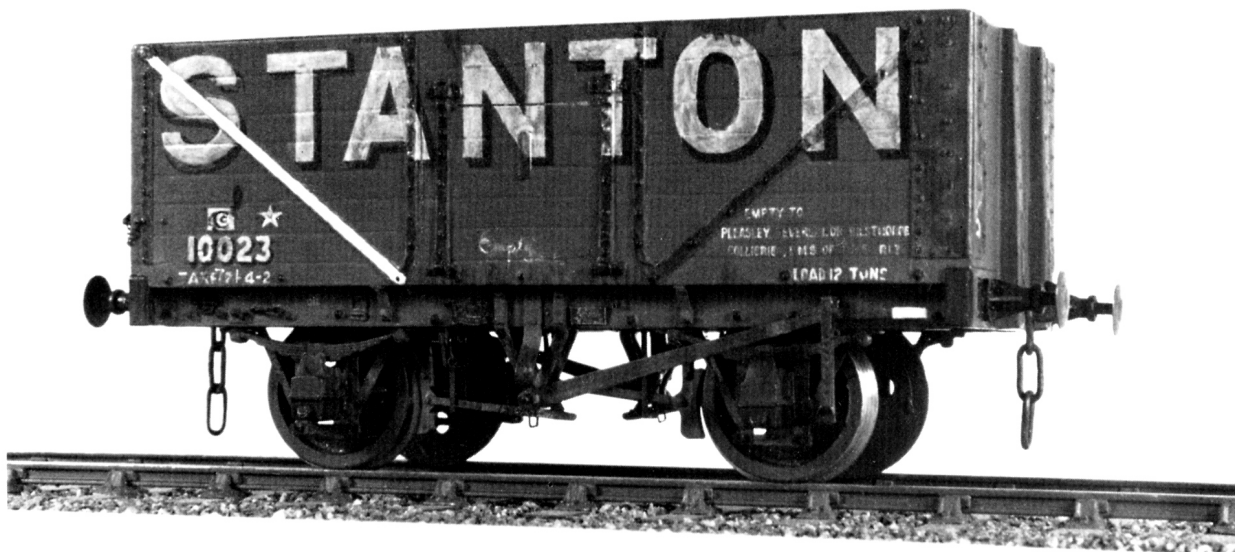
The end of the headstock/siderail area is always a difficult one and this kit was no exception. In an attempt to improve matters I cut pieces of Plastikard to the cross-section of the headstock and chamfered all edges at 45° with a scalpel. These pieces were then stuck on the ends of the headstocks. I can't remember the thickness but I think 0.020in would be about right. I hope this simple modification improved matters, but readers can judge for themselves by comparing the photograph with an unmodified kit.

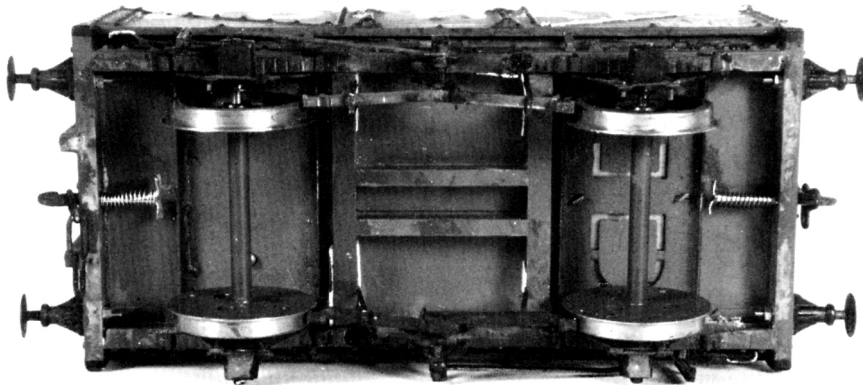
The completed wagon viewed from below.

The brake blocks, push rods, hangers, and tumbler are all in one moulding, and all in one plane when viewed from above. If fitted without modification, either the blocks would be nowhere near the wheels or the tumbler would be nowhere near the vee-iron, because in the full-size wagon the push rods formed a very shallow 'V'. I decided to try to improve things by separating the push rods from the tumbler. Some filing of the hangers was necessary to compensate for the angled push rods, together with some packing to bring the blocks nearer the wheels. This was the only modification I did on the No. 1 side. I wasn't totally happy with the result, but decided to call it a day.

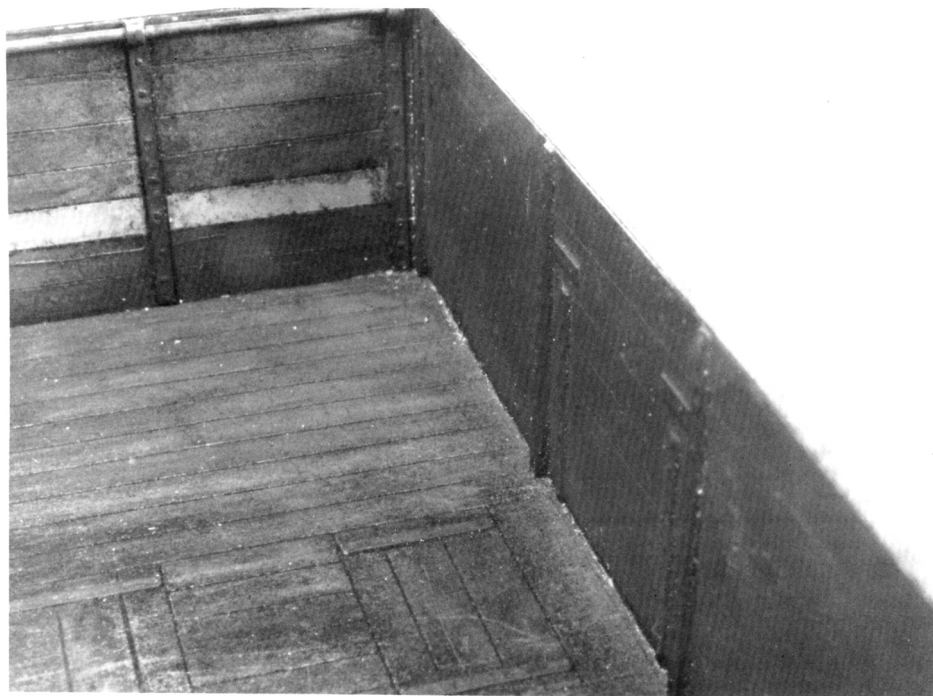
Washer plates and tapered knees complete an uncannily convincing inside.
